NACA TN 3190

FATIGUE INVESTIGATION OF FULL-SCALE
TRANSPORT-AIRPLANE WINGS

SUMMARY OF CONSTANT-AMPLITUDE TESTS THROUGH 1953

By M. J. McGuigan, Jr., D. F. Bryan, and R. E. Whaley

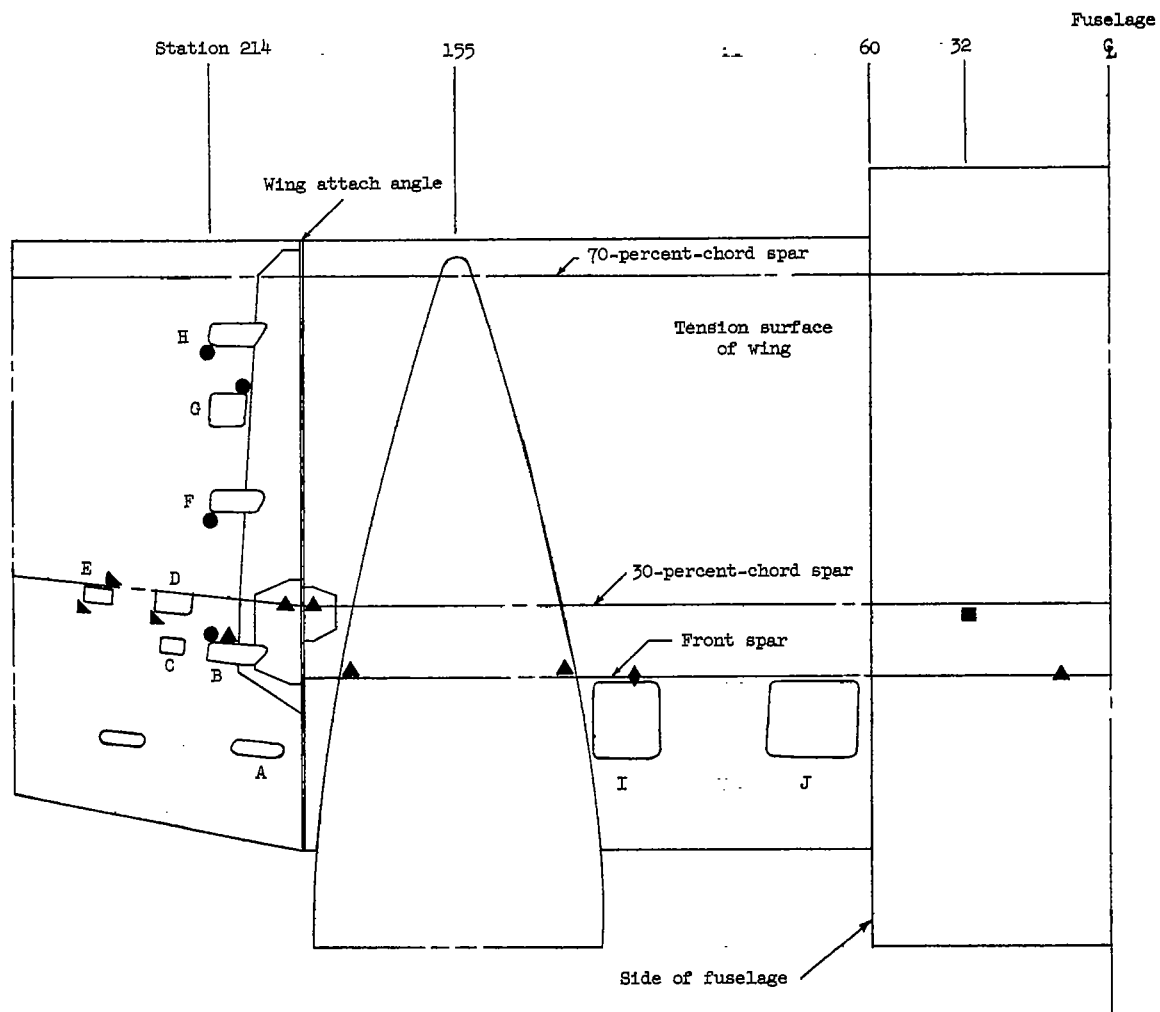
Figure 5.- Locations and types of fatigue failures.

The five types and their locations are shown in the plan view of the tension surface in figure 5, and are illustrated in figures 6 and 7. Most of these types of failures occurred in stress raisers which would be present in similar form on almost any metal aircraft structure.

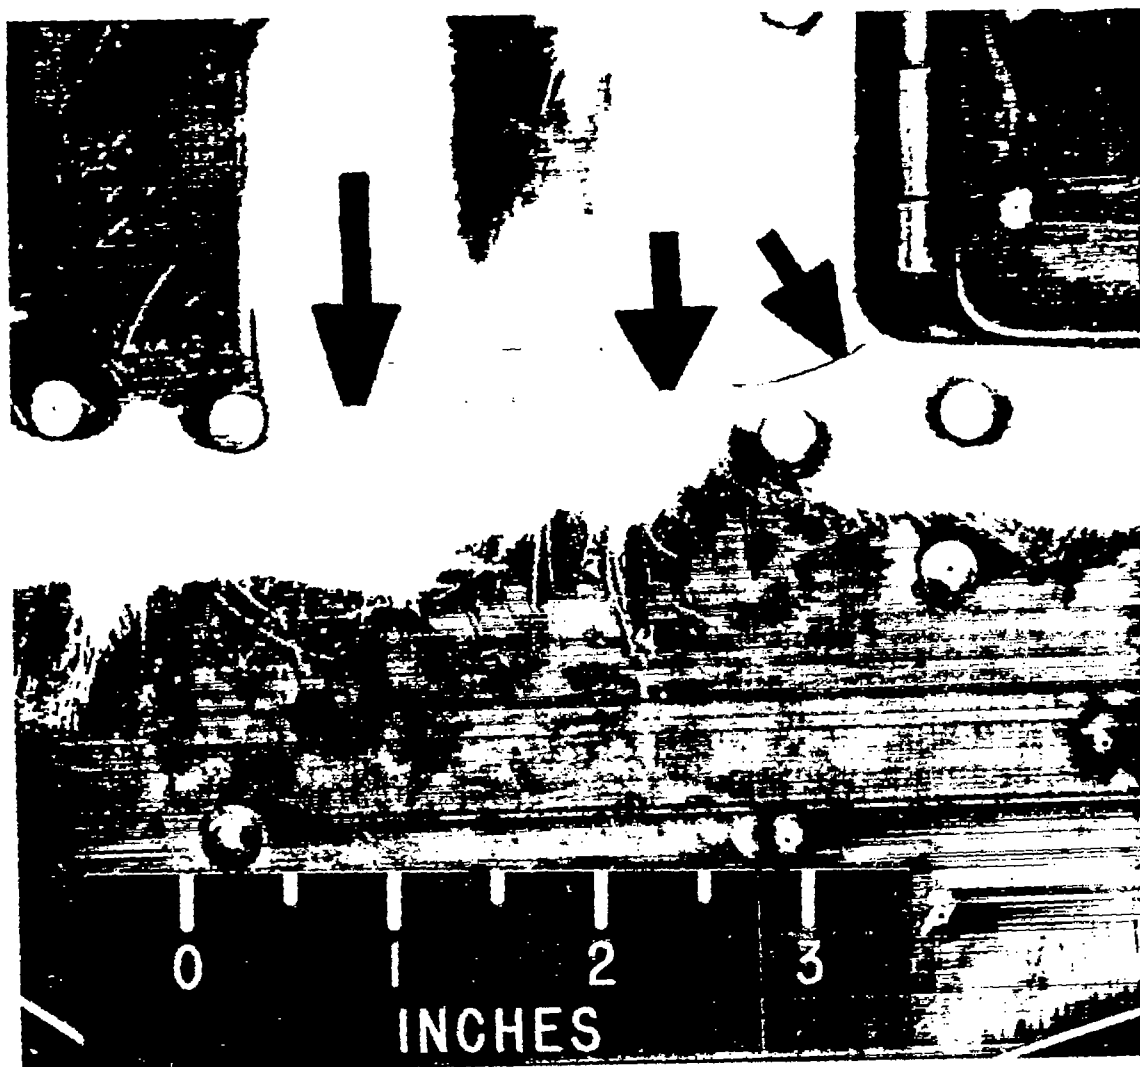
L-77922.4

The type I failures originated in the corners of inspection cutouts B, F, G, and H, and examples are shown in figures 6(a) and 6(b). These cutouts had non-load-carrying covers and were all at span station 214. Most of the failures occurred in the vicinity of the spar at the 30-percent-chord position, which was the most highly stressed region as indicated by the chordwise stress-distribution survey at this station. Since span station 214 contained numerous cutouts, doublers, and other discontinuities and therefore yielded an irregular stress distribution, another chordwise survey was made at span station 235, which was the nearest station that was free of these discontinuities. The gages used in these surveys were oriented so as to measure the strain in a spanwise direction. The results of these surveys are presented in figure 8, along with a cross section of the tension surface at span station 214. This figure indicates that for both of these stations the highest stress occurs in the vicinity of the 30-percent spar.

(a) Type I failure at forward outboard corner of inspection cutout F.

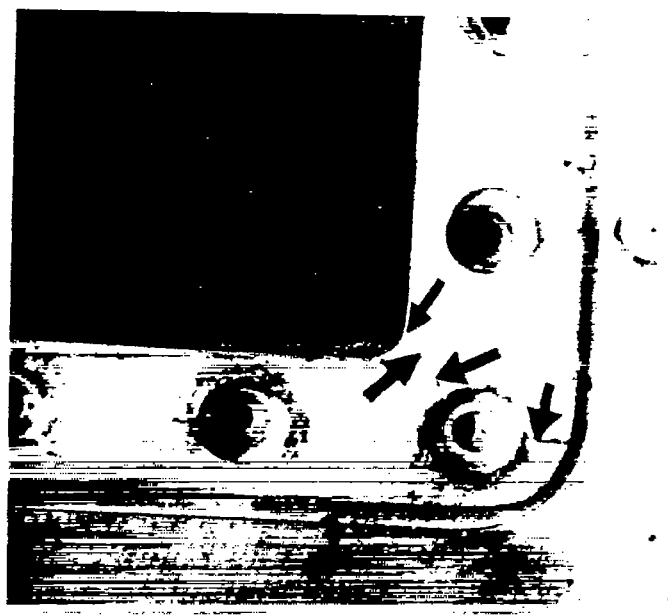
The type IV failures occurred in internal reinforcing doubler plates around cutouts D and E, located outboard of span station 214 and immediately forward of the 30-percent spar. A photograph of this type of failure is presented as figure 6(d). These cutouts had cover plates that were fastened to the reinforcing doubler plate with machine screws and channel nuts. The failures originated in the screw holes on some wings and in the smaller-radius corner of the internal doubler plate on others, frequently occurring very early in a test. These failures spread into the skin on only two occasions but in no case did they grow to more than a few inches in length.

(d) Type IV failure in reinforcing doubler plate at inspection cutout D. L-77924

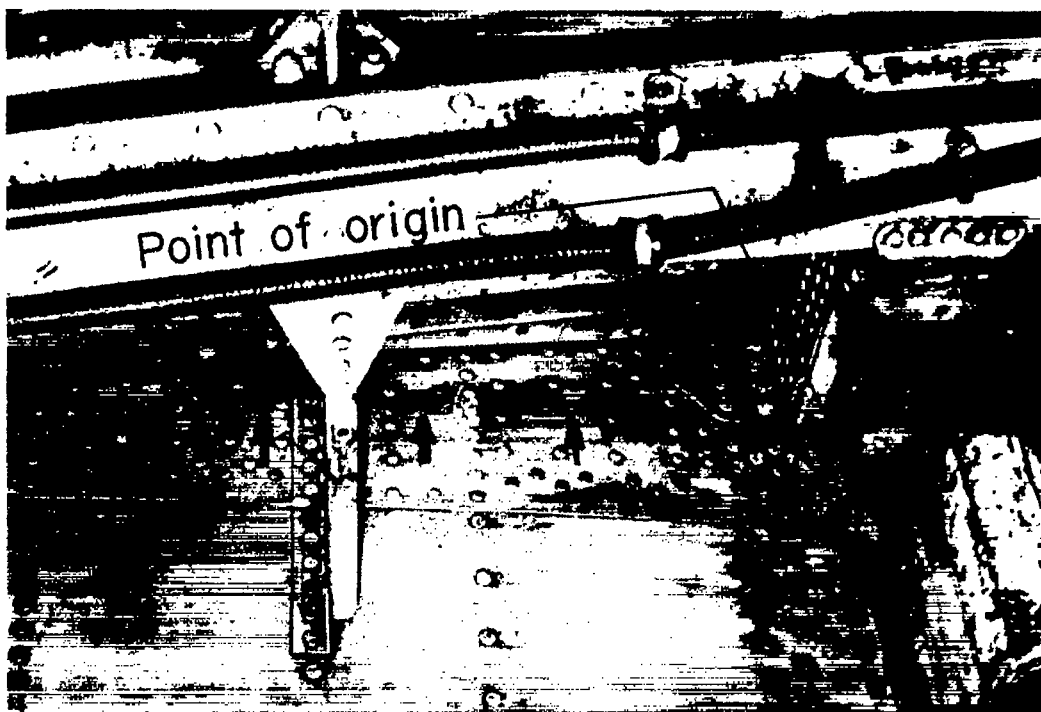
L-67783.1

Type V includes all the failures that could not be classified in one of the preceding types. Several failure locations are included in this type, but at only three of these did failures repeatedly occur. One of these locations was in a joggle in an external doubler plate about 3 inches outboard of the wing attach angle and directly over the 30-percent spar. These failures occurred only at the two highest load levels and an example is presented in figure 6(e). Another type V failure occurred in the skin at the edge of the external attach-angle doubler plate, between the 30-percent spar and cutout B. A photograph of this failure location is presented as figure 6(f). Strain-gage measurements indicated this region to have a higher nominal stress than any other location where strain-gage measurements were made. These failures occurred at every test level. Another failure location of type V was inside the engine nacelles at span station 180 in a doubler plate over the front spar. A notch had been cut in the edge of the doubler plate to allow clearance for the rotation of the landing-gear strut during extension and retraction of the landing gear, and the failures started either in the notch or at a rivet near the notch. In some cases the notch had been hand cut and in others the notch was cut by rotation of the landing-gear strut itself. A photograph of this failure is presented as figure 6(g).

(g) Type V failure inside engine nacelle.

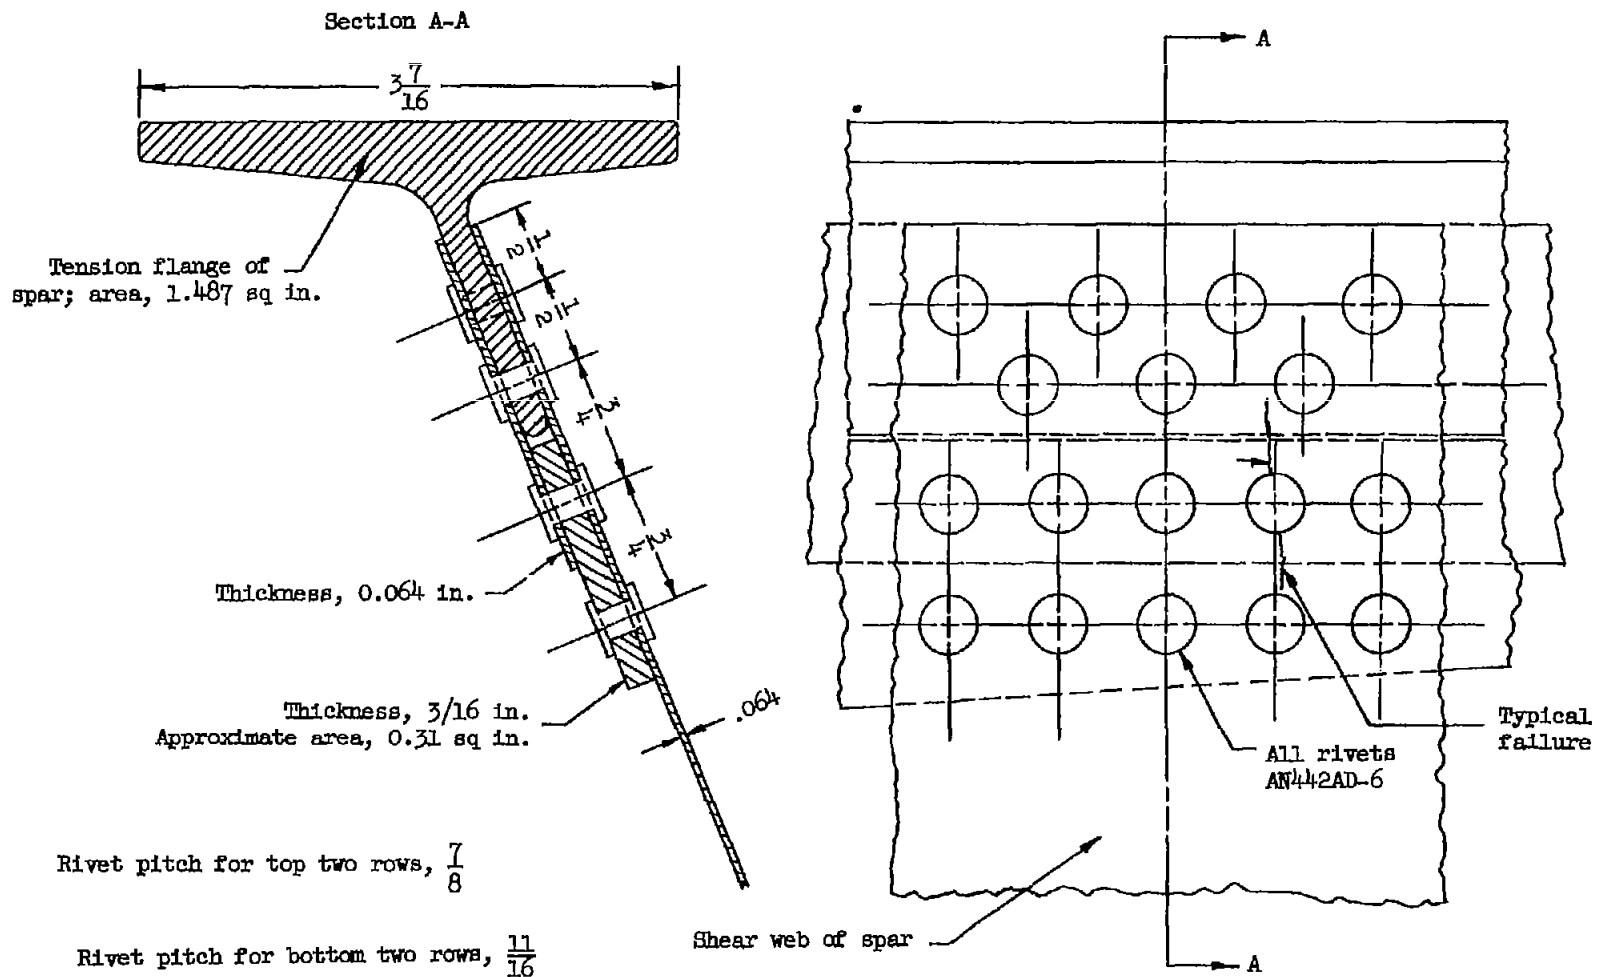
Figure 7.- Details of riveted shear joint at span station 120 in which type III failures occurred.

The type III failures occurred at span station 120 in the riveted joint connecting the shear web to the tension flange of the front spar. Since this location was very difficult to photograph, a drawing of the details of this joint is shown in figure 7. The cracks usually progressed vertically through the shear web and were accompanied by a crack in a small piece of skin over the spar cap.
